Nonpoint Source Implementation Strategies

Hamley Run – Hocking River

HUC 12 # 05030204 08 01

Version 1.0

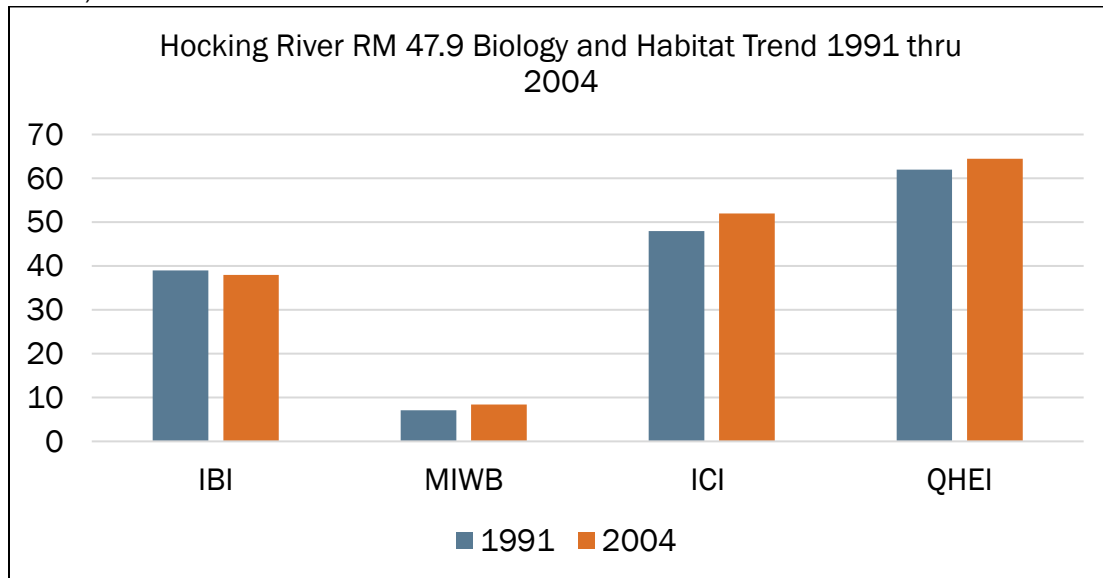
Figure 10

Hocking River Habitat and Biological Score Comparison 1991 Vs. 2004 (OEPA, 2009; OEPA, 1991)

Biological and habitat sampling results collected in 1991 in the Hocking River at RM 47.9/48.5 are comparable to sample results collected in 2004 at the same site (Figure 10). In 1991 RM 47.9 was in partial aquatic life use attainment with an IBI score of 39, a MIwb score of 7.1, an ICI score of 48, and a QHEI of 62 (OEPA, 1991). In 2004 the same site was found to be in full aquatic life use attainment with an IBI score of 38, a MIwb score of 8.4, an ICI score of 52, and a QHEI score of 64.5 (Figure 11) (OEPA, 2009). Although the aquatic life use attainment status changed between 1991 and 2004 there did not appear to be a significant difference in the biological scores. Improvement in the MIwb score from 7.1 in 1991 to 8.4 in 2004 resulted in the change in aquatic life use status. In general the 1991 and 2004 sample results were very similar and are barely attaining full warm water habitat status indicating that there is a need to improve and stabilize this reach of the Hocking River.

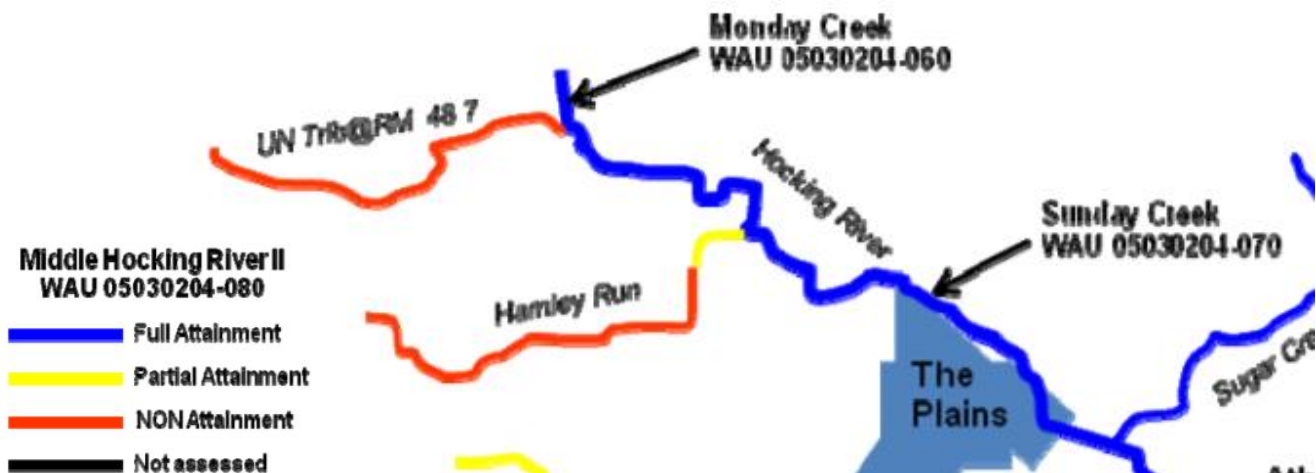
Figure 11.

Aquatic Life Use Attainment in the Hamley Run – Hocking River HUC 12 (OEPA, 2009)

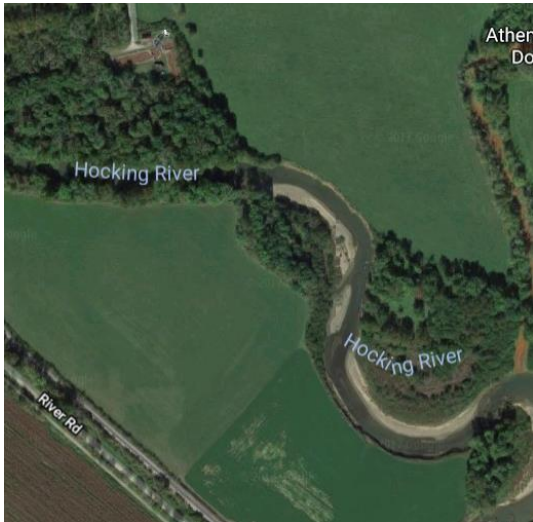
Figure 14

Critical Area 1 – Reach 1

- Reach 1 (Figures 14, 18, and 19) – Located between RM 42.9 and 43.3 in Section 20 of Dover Township. This reach accounts for 1900 linear feet of erosion and 7,978 tons per year of sediment (67%).

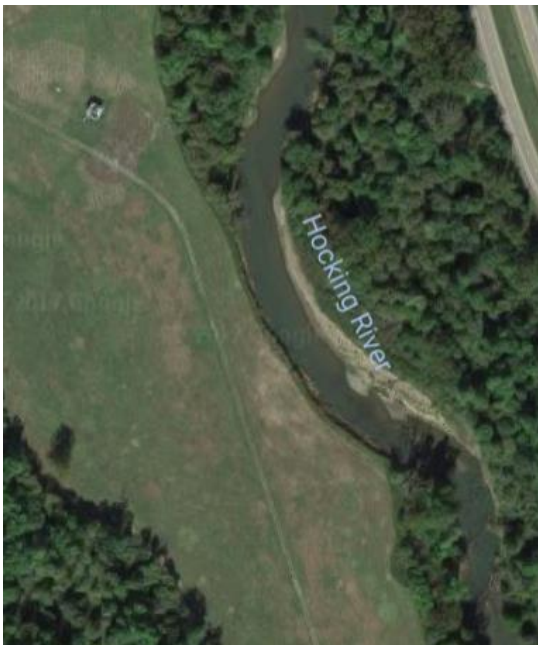
Figure 15

Critical Area 1 – Reach 2

- Reach 2 (Figure 15) – Located between RM 45.5 and 45.7 in Section 31 of Dover Township. This reach accounts for 535 linear feet of erosion and 1040 tons per year of sediment (9%)

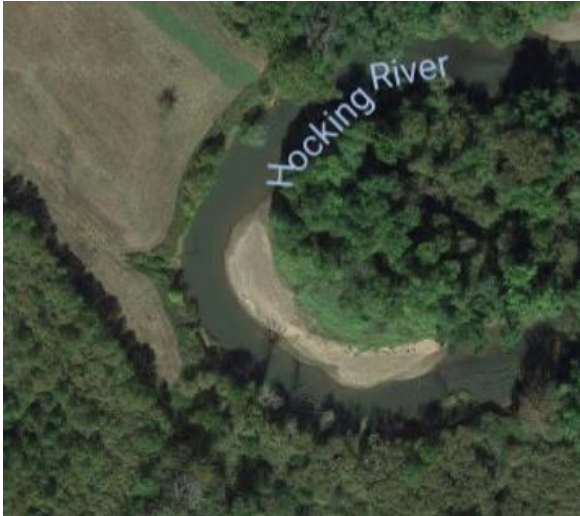
Figure 16

Critical Area 1 – Reach 3

- Reach 3 (Figure 16) – Located between RM 46 and 46.2 in Section 32 of Dover Township. This reach accounts for 430 linear feet of erosion and 321 tons per year of sediment (3%).

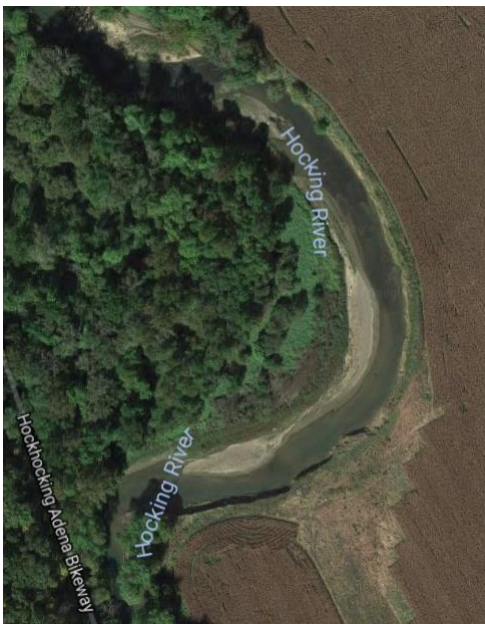
Figure 17

Critical Area 1 – Reach 4

- Reach 4 (Figure 17) – Located between RM 48.4 and 48.6 in Section 9 of York Township approximately 1/3 of a mile upstream from the County Road 4 bridge. This reach accounts for 880 linear feet of erosion and 2,530 tons per year of sediment (21%).

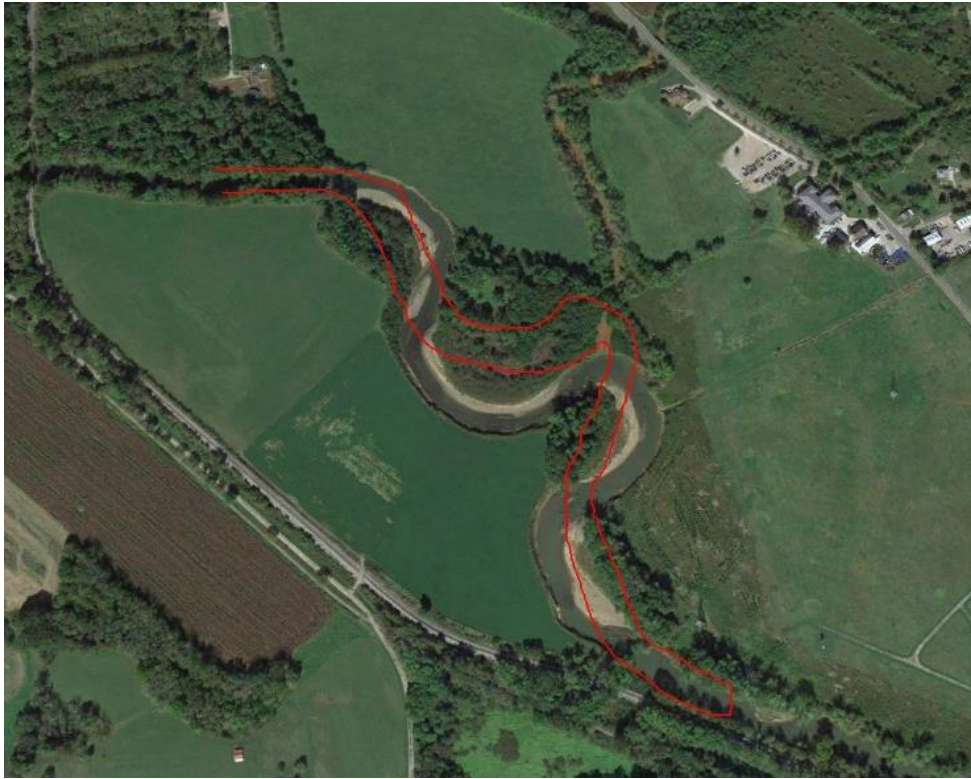
Figure 18

Hocking River between River Miles 42.6 and 43.3 (2015). Red line represents stream channel location in 1994 (Hocking, 2015)

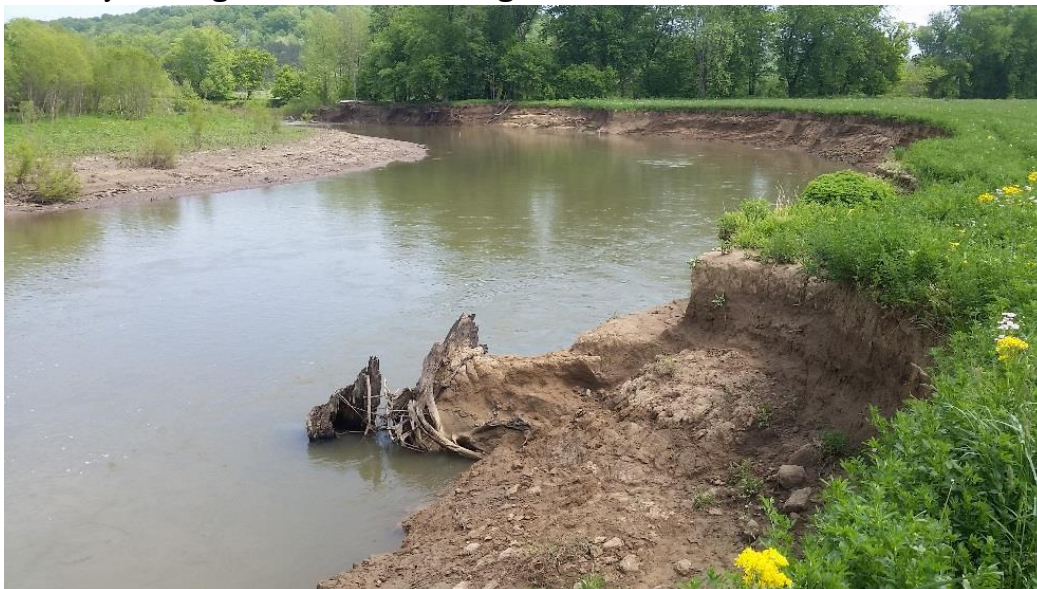
Figure 19

Severely eroding bank on the Hocking River at RM 43

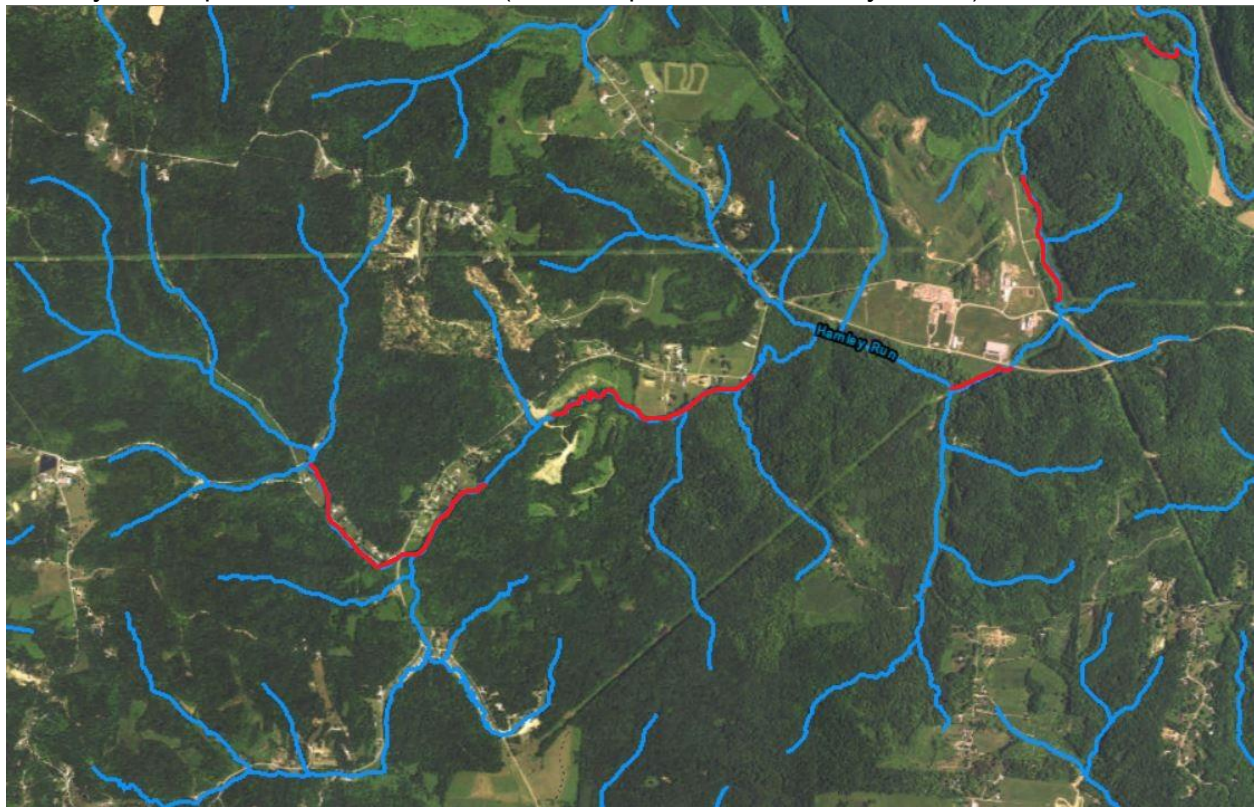
Figure 21

Hamley Run Riparian Encroachment (base map – Ohio University, 2017)

- Objective 2.1. Restore and maintain wooded riparian corridors
- Restore 13,280 linear feet of riparian corridor along the mainstem of Hamely Run (Figure 21)
- Objective 2.2. Restore and enhance instream habitat and substrate
- Restore a total of 900 linear feet of habitat within the stream channel at RM 0.4 and 2.1.
- Objective 2.3. Inspect HSTS and Alternative systems
- Inspect 120 systems (estimated number of systems within the subwatershed according to the Athens County Health Department)
- Objective 2.4. Repair and replace failing HSTS systems
- Repair and replace 30 systems (estimated number of systems failing according to the Athens Count Health Department)
